4.2.5 South Elevation

4.3 Internal Analysis and Recommendations

4.4 Condition Assessment by Engineer

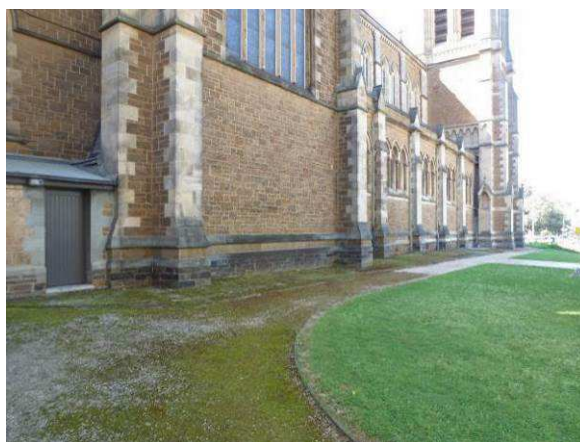
Details of base of South Elevation showing downpipes discharging water on the ground, causing damp ground

- Any galvanised downpipes or spreaders should be changed to copper
- Replace internal tower gutters (inside north and south towers) now rusted out, and renew associated down pipe to ensure discharge of tower roof water.

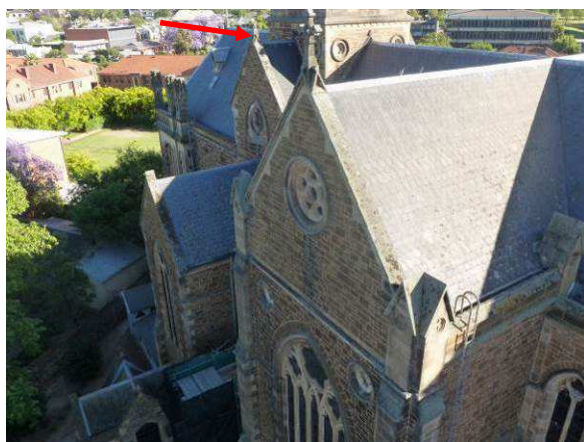
View down on South Elevation (arrow where cross fell down)

One of the stone crosses at the top of a southern gable broke and fell onto the adjacent roof during a particularly strong wind in September 2013. The cross appeared to be fixed in place on the wall with a dowel, and the cross broke by fracturing through the stone at the base of the cross.

The crosses are considered to be vulnerable under high wind or earthquake loading, and removal and reinstatement with a reliable method of fixing is recommended.

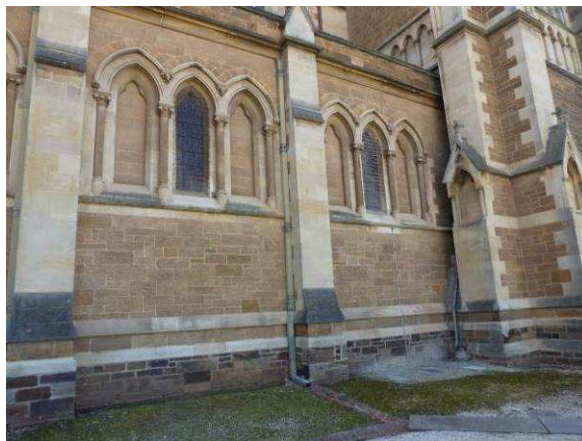
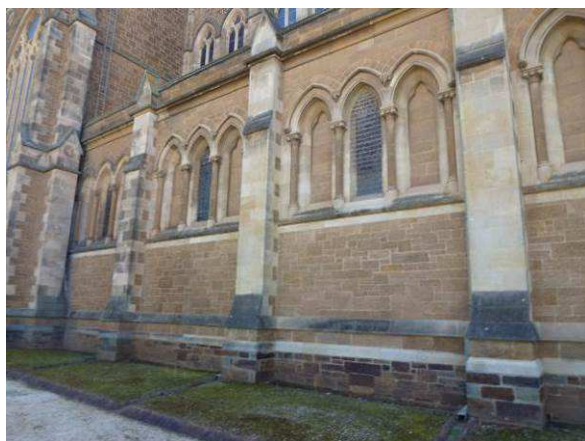
Base of South Elevation - steps to porch (left) and downpipes discharging water into brick drains

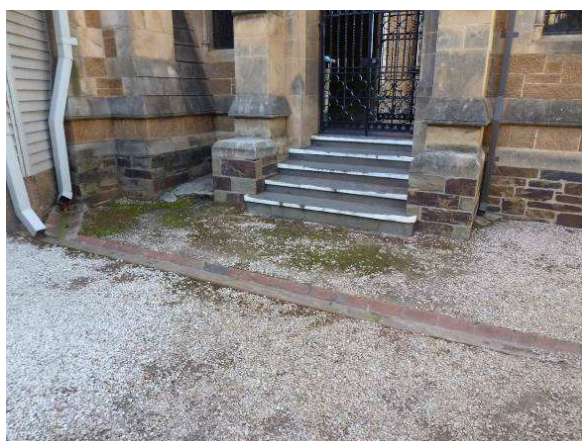
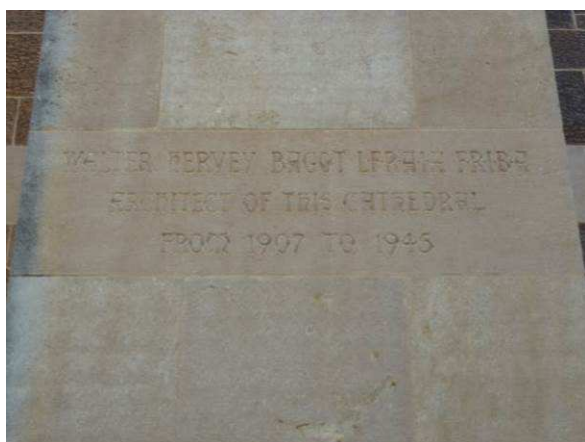
Base of South Elevation - downpipes discharging water into brick drains

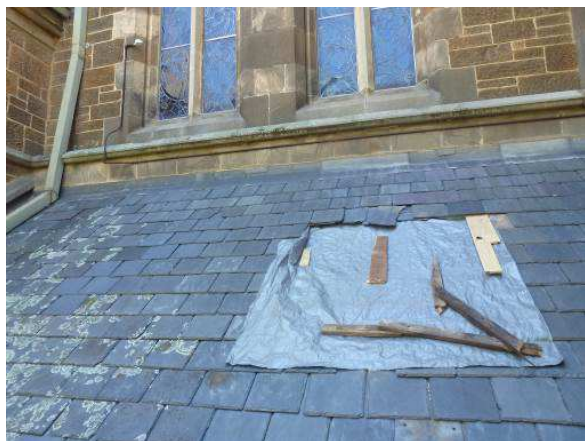
Damage to roof due to storm

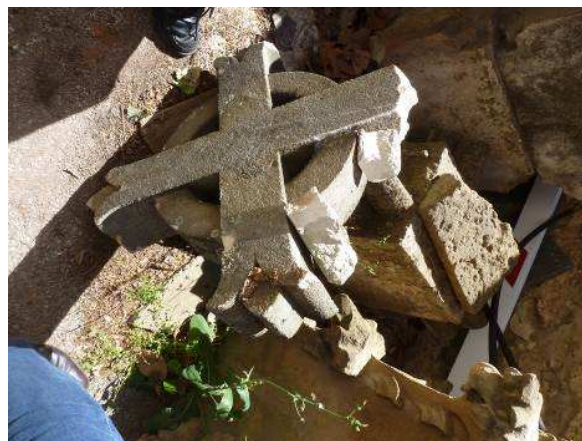
Damage to roof due to storm

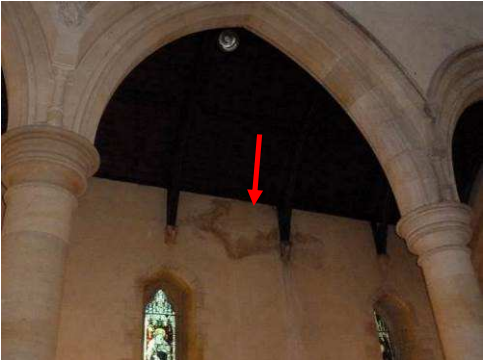
</div> <p>Water damage on the southern wall of the nave/aisle</p> <div>

Previous water entry is evident at the top of both the Nave aisle walls below the box gutter. This would now be the location of drummy render and there are also sections of drummy render in the Nave walls, likely also adjacent to the Lantern Tower cracking. Later patching is evident in the Lantern Tower adjacent to where the point of the rood is fixed.

Recommendations: Once external conservation works have been undertaken, repair all drummy render internally associated with external leaks. Ensure that new render matches colour and consistency of the existing render, undertaking trial samples for checking prior to undertaking full works.

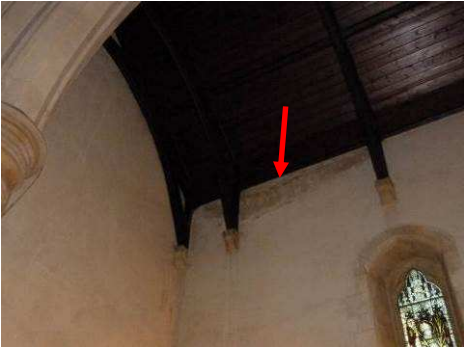
</div> <p>Water damage on the southern wall of the nave/aisle - eastern end</p>

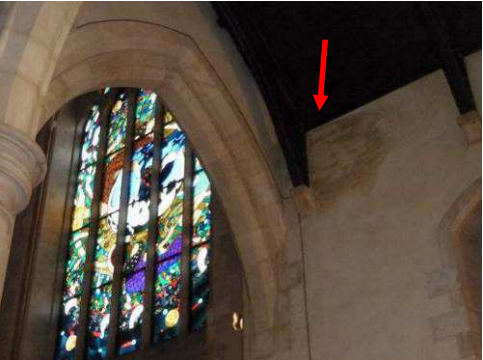
<p>Water damage on the northern wall of the nave/ aisle - adjacent to transept</p>

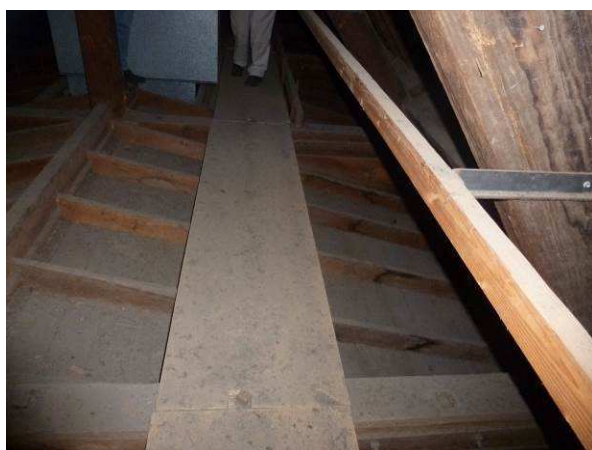
Walkway showing long span

- Splitting in the central vertical timber of the truss, also some opening of the top connection joint of the central vertical
- Some minor splits in other timbers
- The walkway in the roof space is structurally unsound and must be replaced

The central walkway is defective and should be replaced, as well as the roof access platform to the central walkway.

- Provide plywood gusset plates to restrain the top of the central timber vertical in the roof trusses
- Replace the ceiling walkway and roof access platform
- Provide plywood strengthening plates along split roof timbers
- Review the condition of the roof crosses regularly (maximum biannually) for deterioration and repair as necessary, or alternatively carry out restorative work to all roof crosses now.

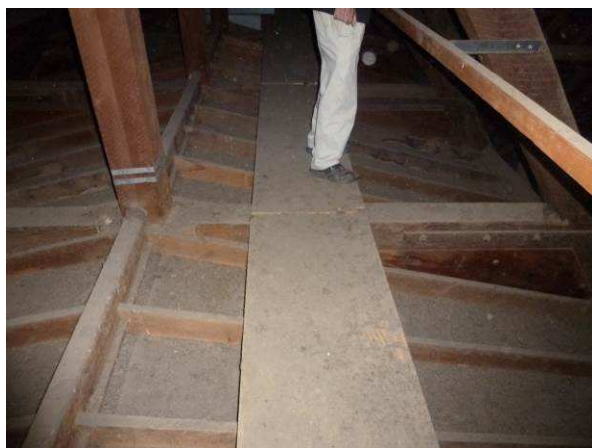
Walkway

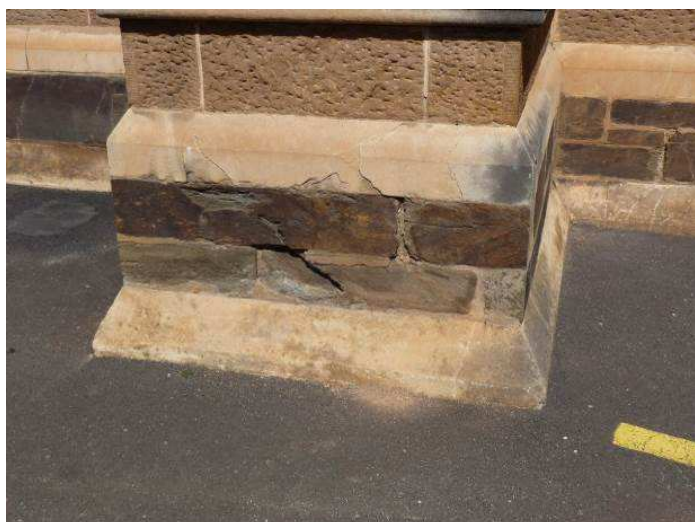
Glen Osmond Bluestone Plinth, with limestone banding (North Elevation, Bay E2 – note deterioration)

Recommendations: Continue to maintain and clean stone. Undertake all stone conservation works as identified in the dilapidation survey accompanying this report, and to the method statements outlined in Section 6 of this report.

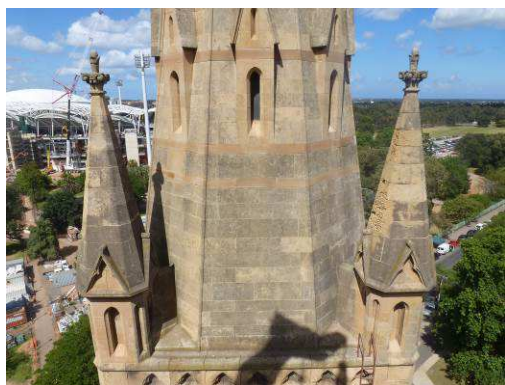
Spire, showing deteriorated limestone (arrowed) and banding of Pyrmont Stone
