CONSERVATION STRATEGY ST PETER'S CATHEDRAL NORTH ADELAIDE

March 2014

CONSERVATION STRATEGY FOR ST PETER'S CATHEDRAL

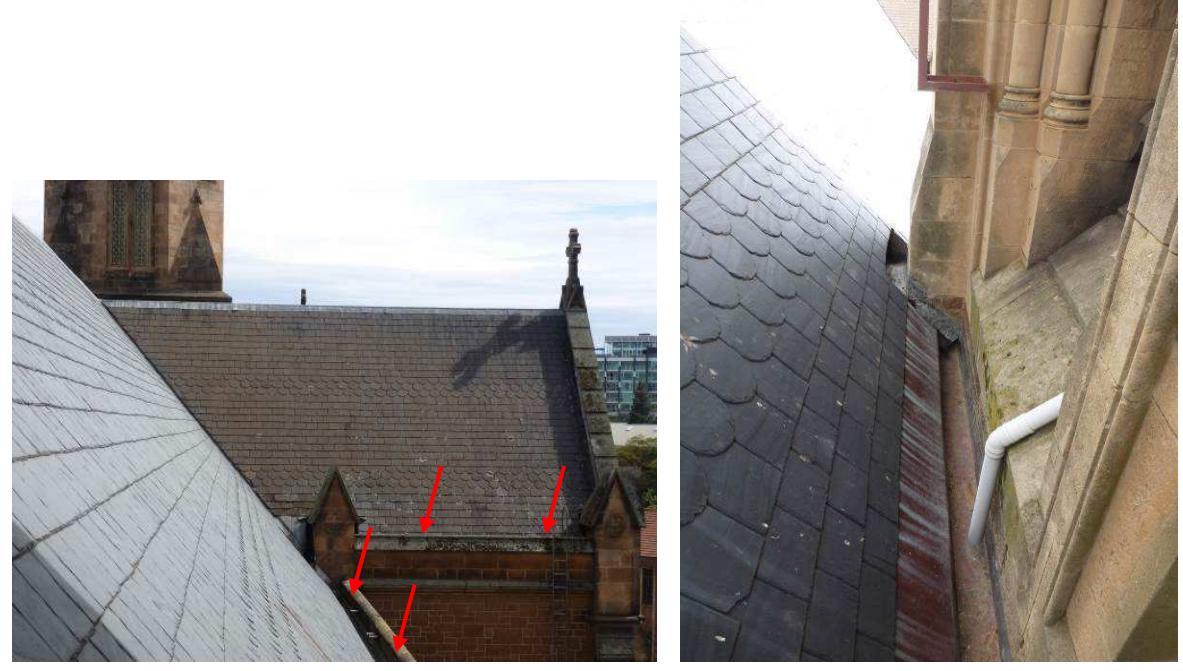
Views of the roof, (see box gutter arrowed) problems of leakage internally are located at areas of box gutters, which, in the past, have not discharged water, and have overflowed. RHS photo shows down pipe which discharges from internal gutter in the tower

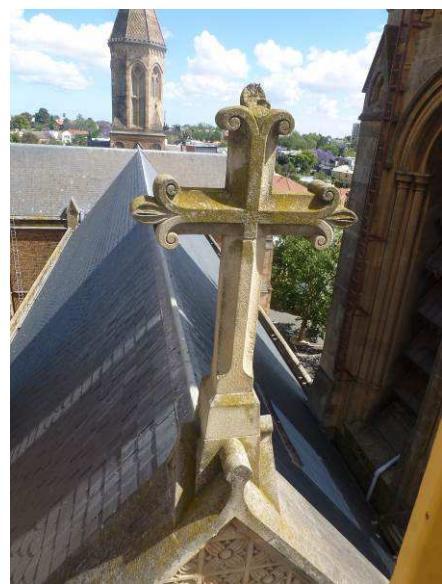
Cross on the front east elevation - note cracked stone at apex

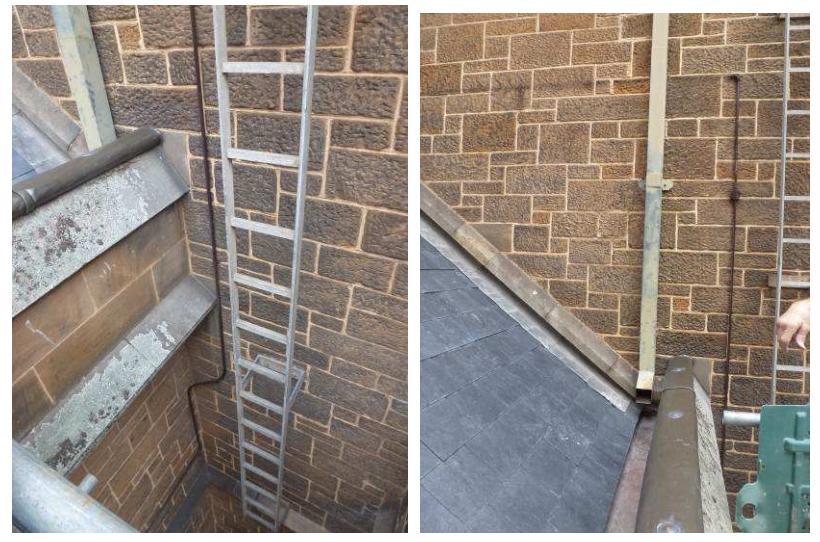
Access ladders all require fall arrestors, galvanised down pipe into copper gutter

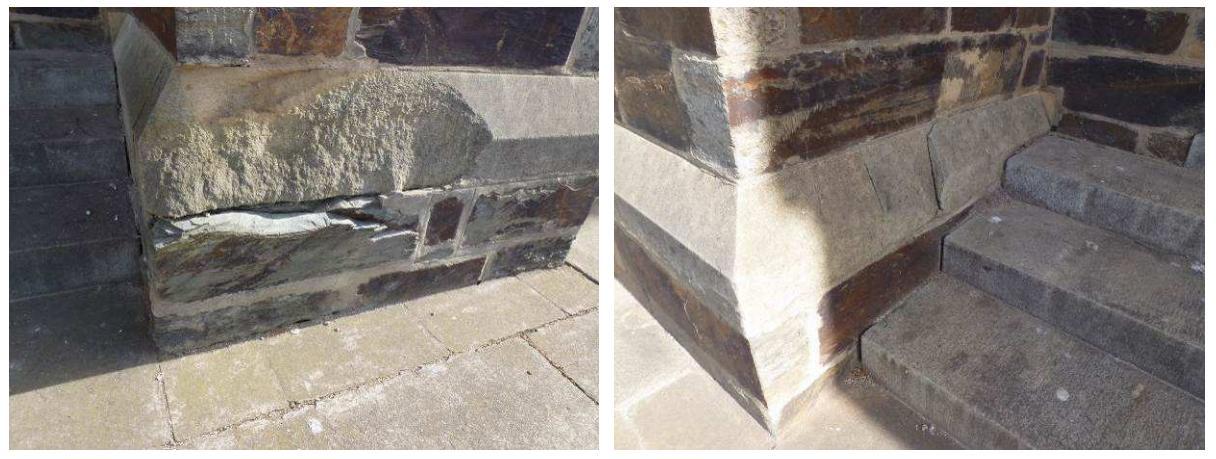
Damaged stone at base of wall in the bluestone and limestone plinth

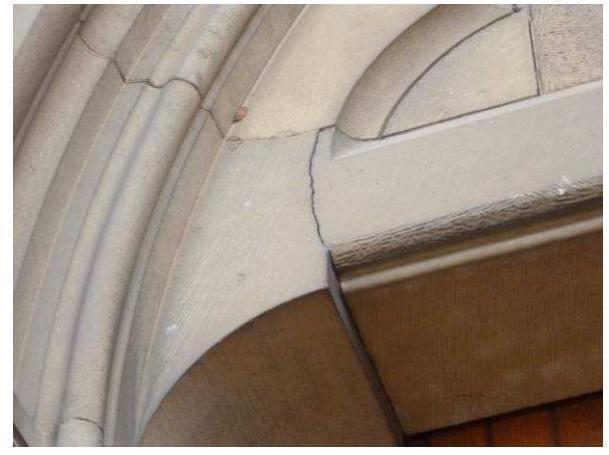
Cracked stone lintel over entry door

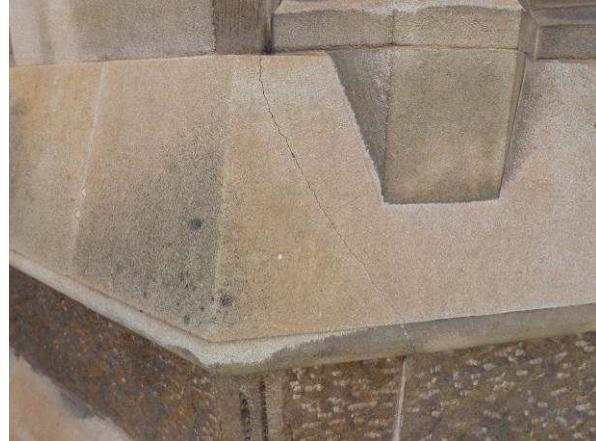
Typical stone fracture

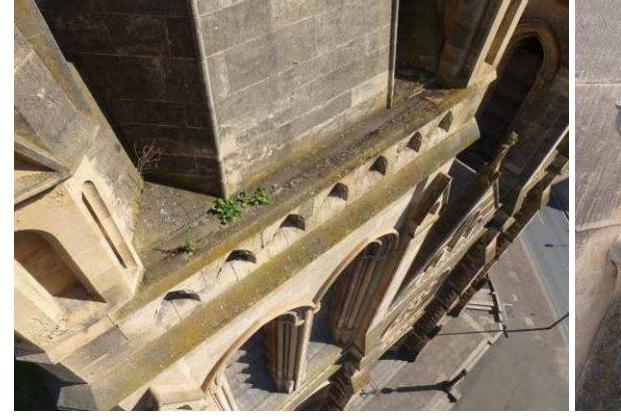
Tower E33 - showing water collection on ledge

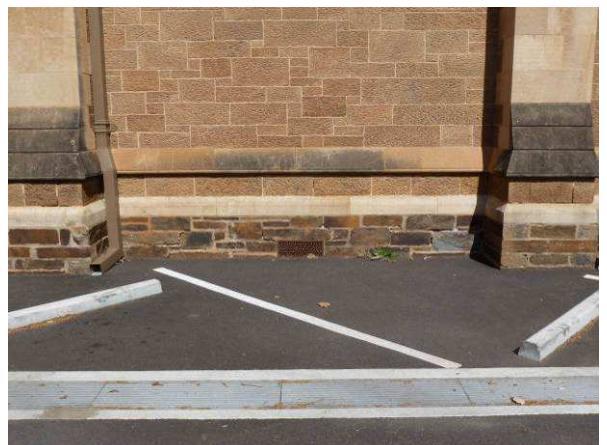
Bitumen sealing to base of wall

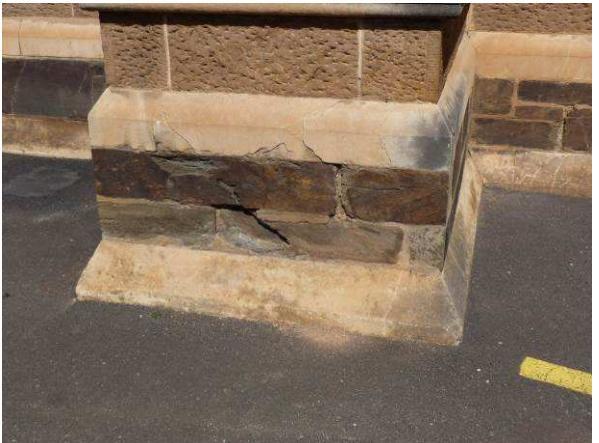
Damaged stone to plinth

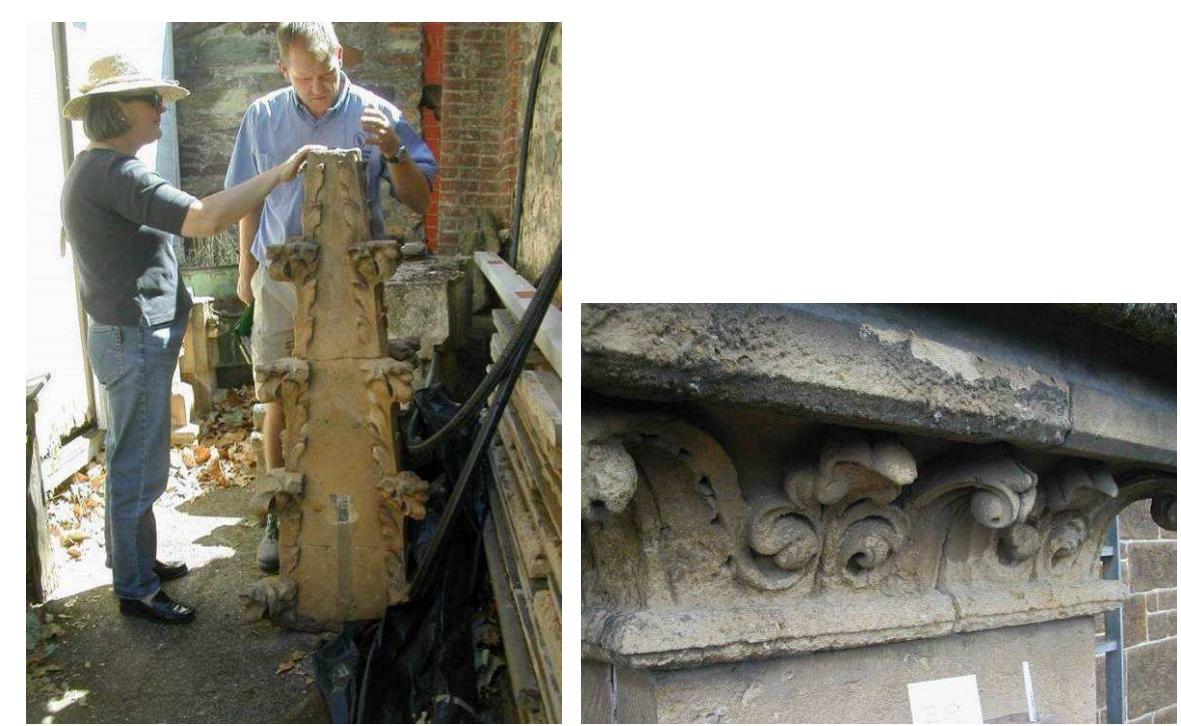
View of pinnacle now on the ground

View of deteriorated cornice (photo taken in 2004)

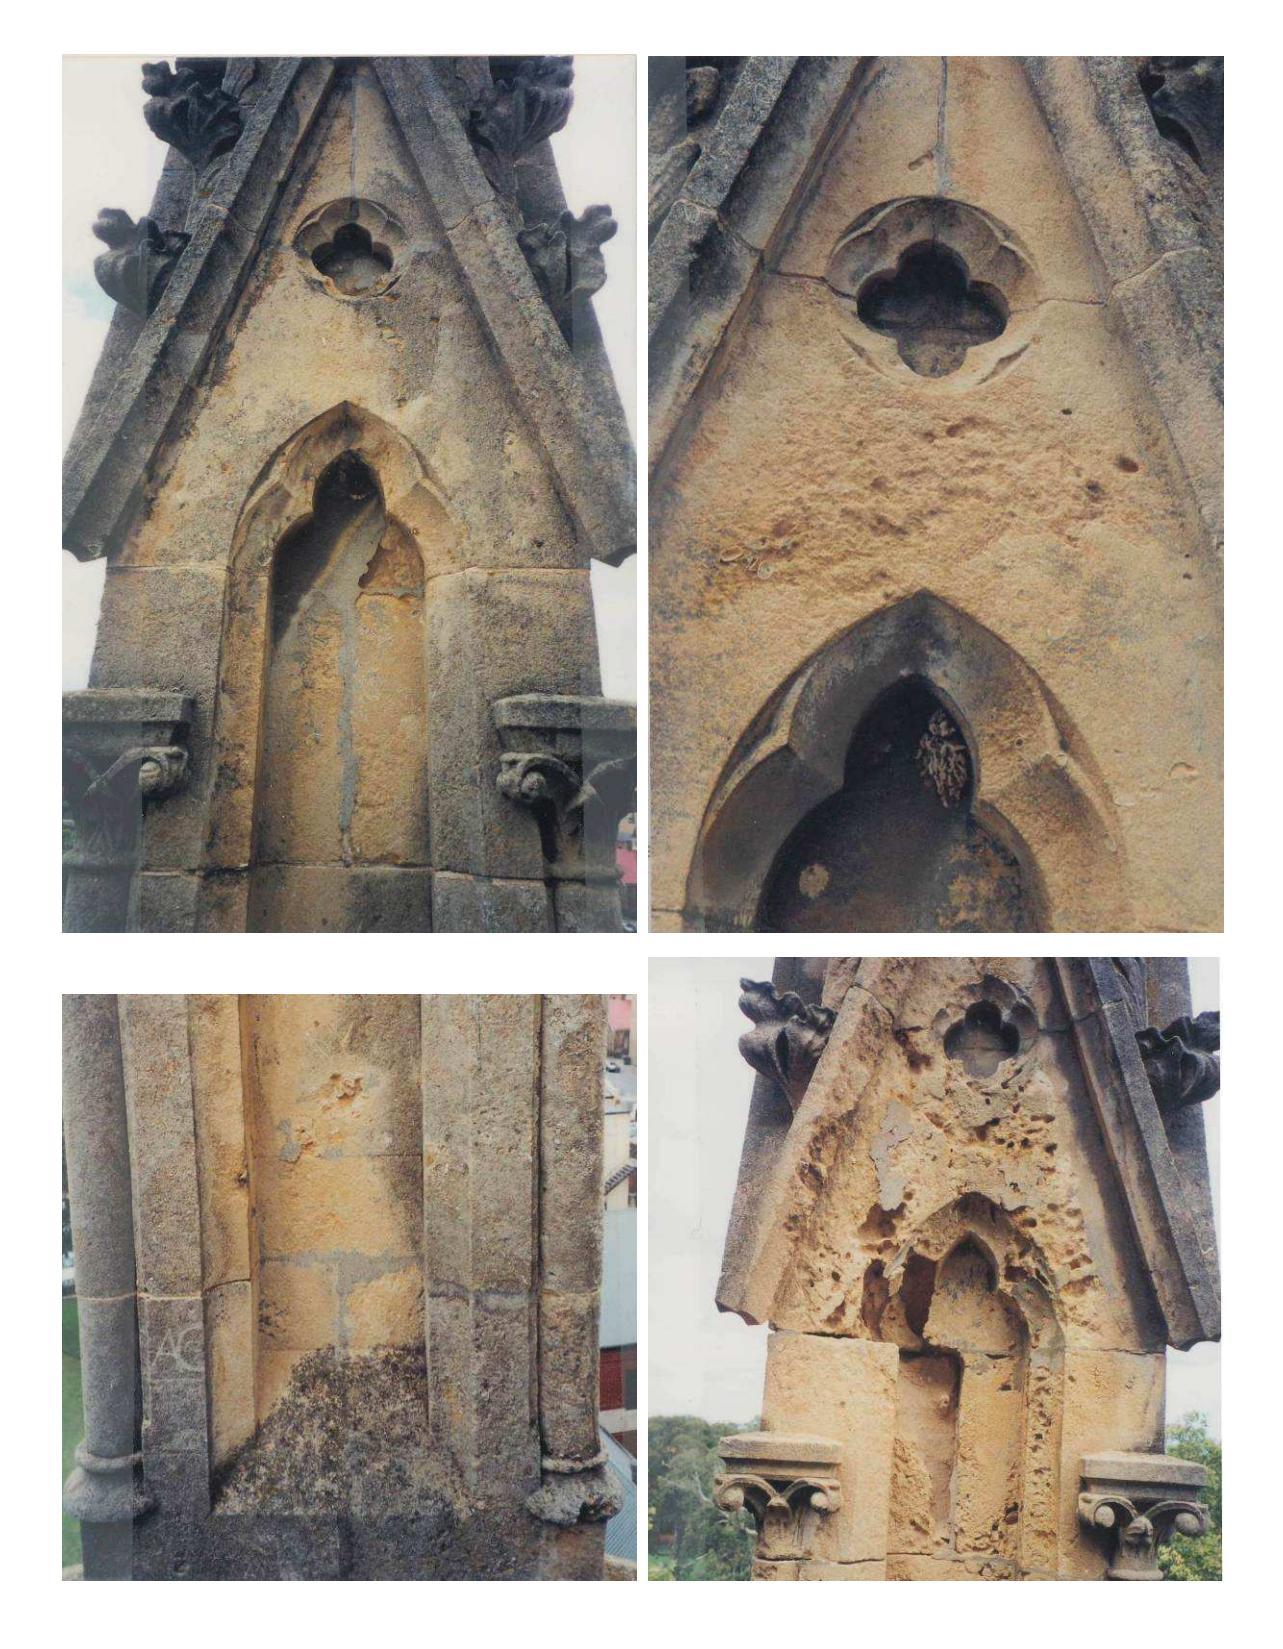
DETERIORATION OF CORNICE, BALUSTRADE AND PINNACLES (November 2013 photos)

Damage includes:

- Pitting & washing away of stone face
- Cement render repairs
- Deterioration of copper reinforcing rod
