CONSERVATION STRATEGY ST PETER'S CATHEDRAL NORTH ADELAIDE

March 2014

CONSERVATION STRATEGY FOR ST PETER'S CATHEDRAL

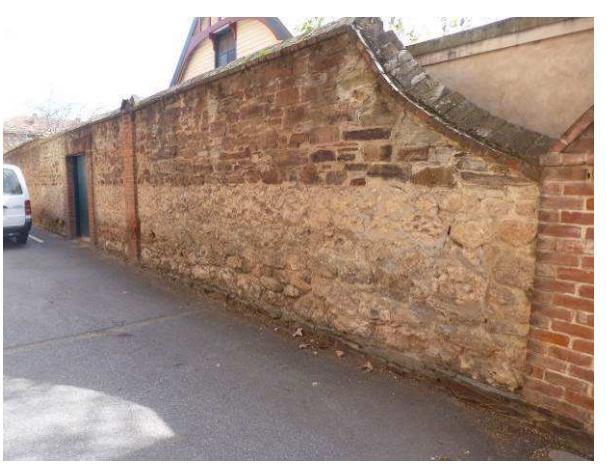
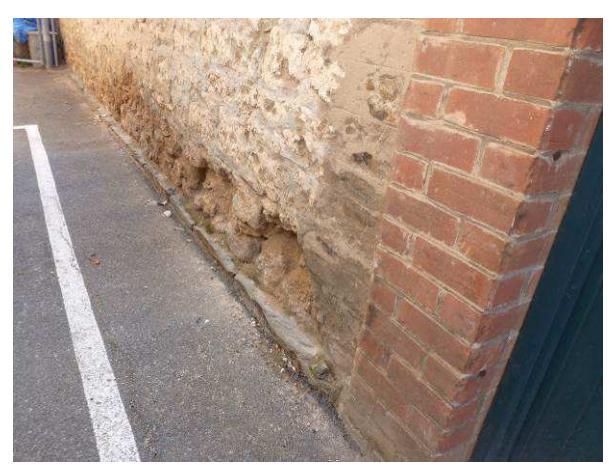
The northern wall separating the Cathedral from the Cathedral Close is a mixture of limestone and bluestone in fair condition, although with random cement patching and areas where the stone has deteriorated and worn away.

Limestone and bluestone wall between parking and the cathedral office area

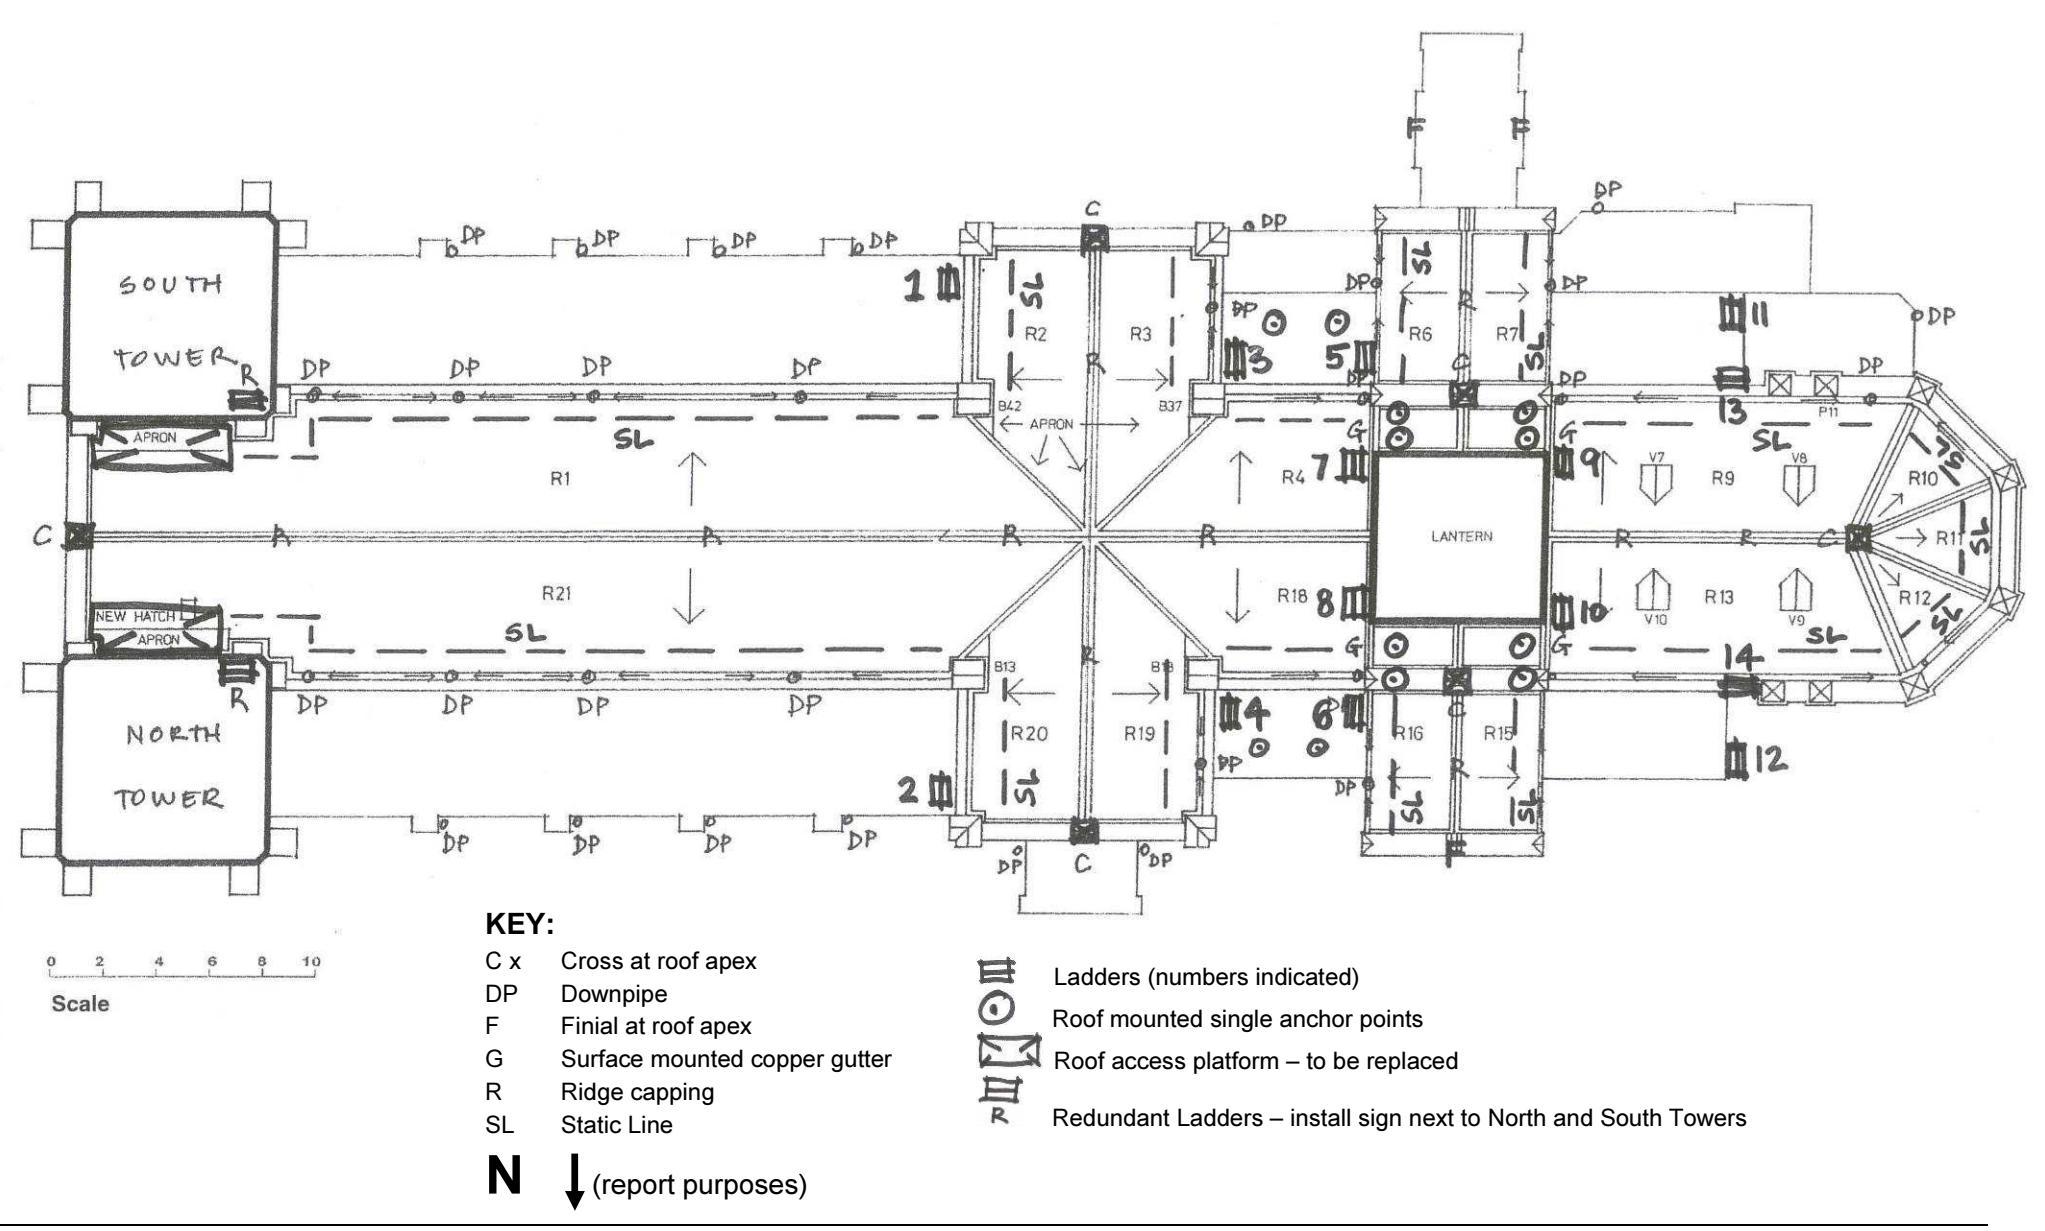
Views of the roof, (see box gutter arrowed) problems of leakage internally are located at areas of box gutters, which, in the past, have not discharged water, and have overflowed. RHS photo shows down pipe which discharges from internal gutter in the tower

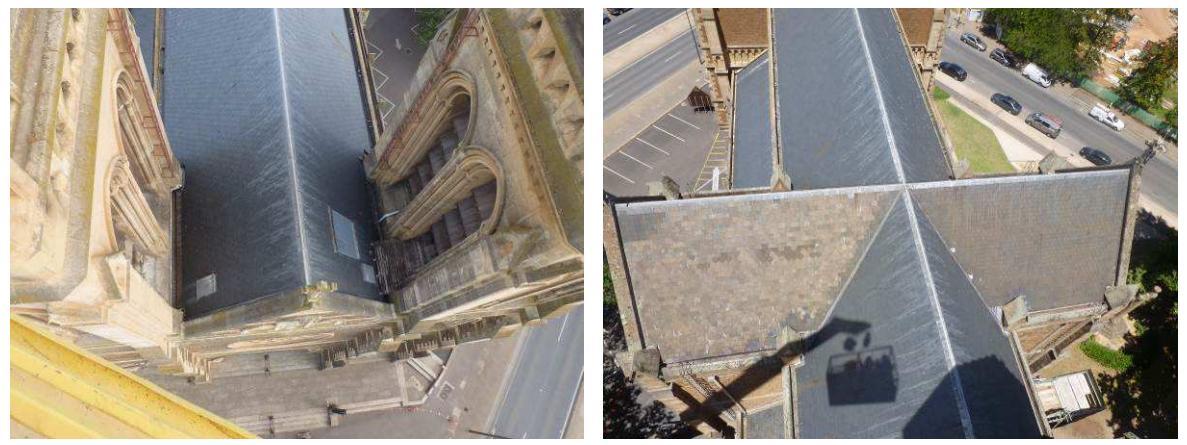
View down on box gutter between the towers. View of valleys and gutters at the location of the transepts

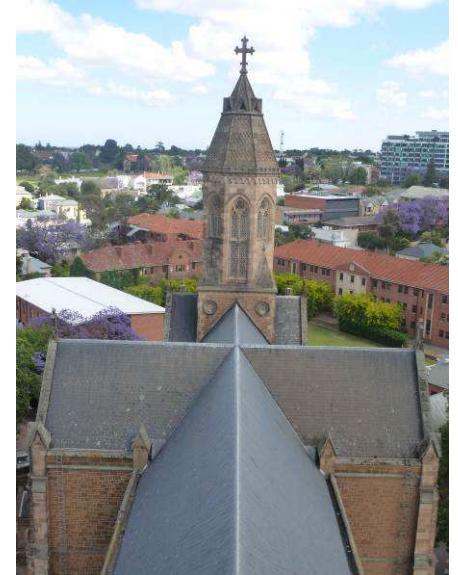
Roof next to lantern tower

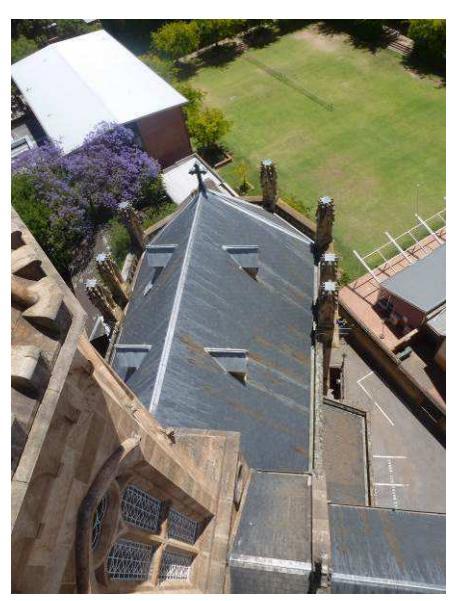
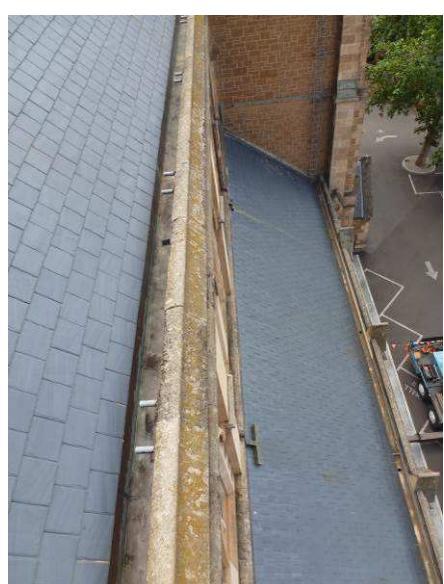
Lady Chapel Roof (which retains vents) Nave clerestory gutter – showing scaffold bolts to be removed

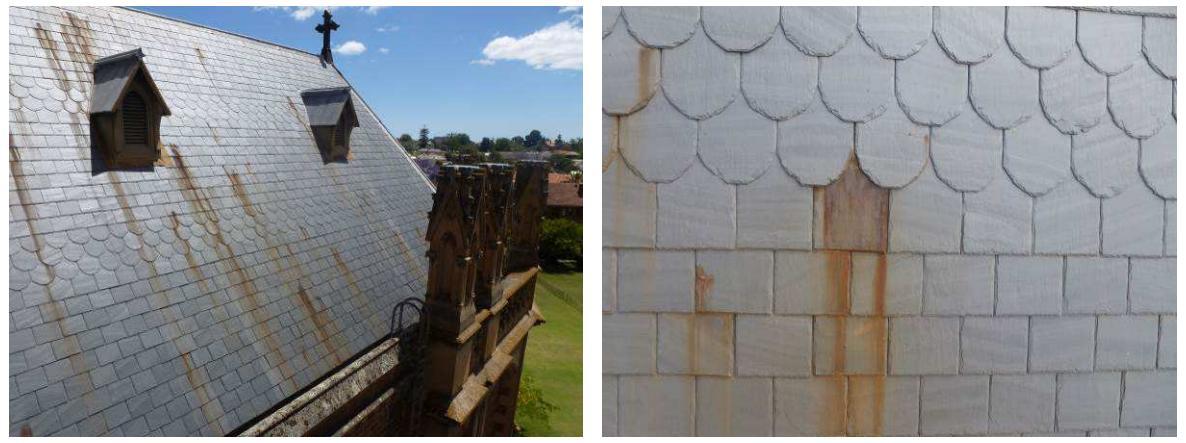
Lady Chapel Roof

Detail to Lady Chapel roof - showing typical mineral staining

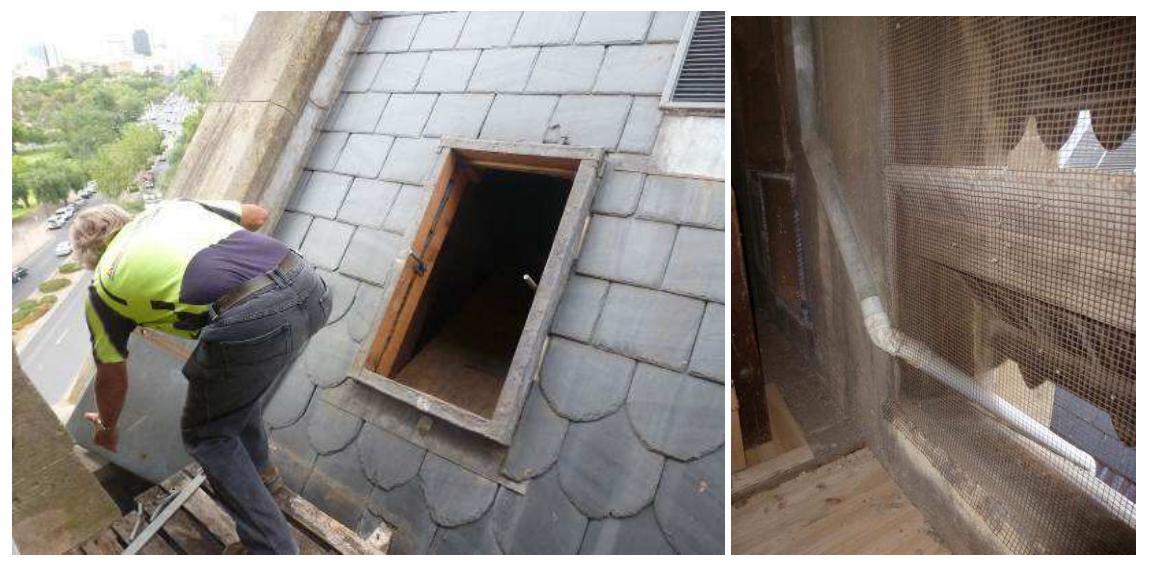
Access to the roof via hatch

Roof drainage in the tower – internal down pipe inserted to collect water from upper internal gutter

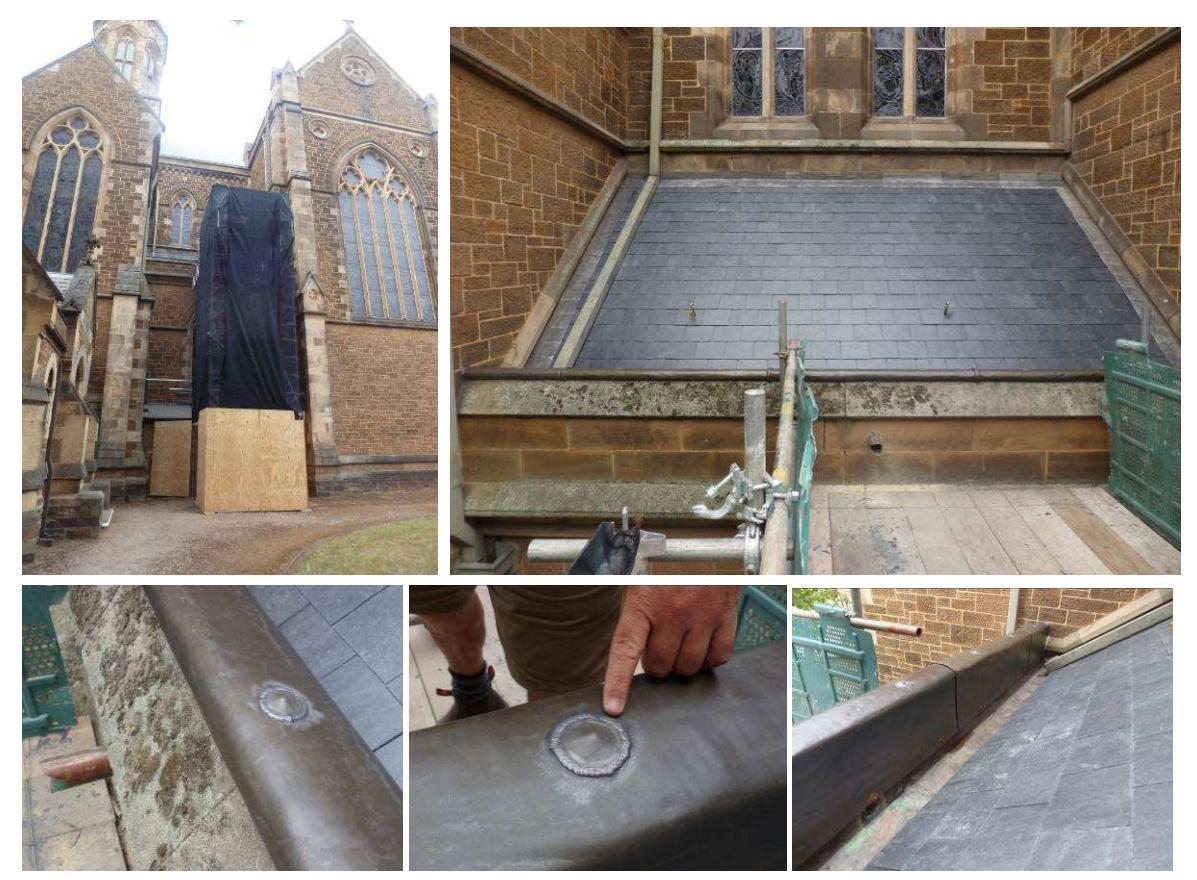
Lead flashing over top of parapet, flashed into the copper gutter, detail of fixing of top of lead capping.

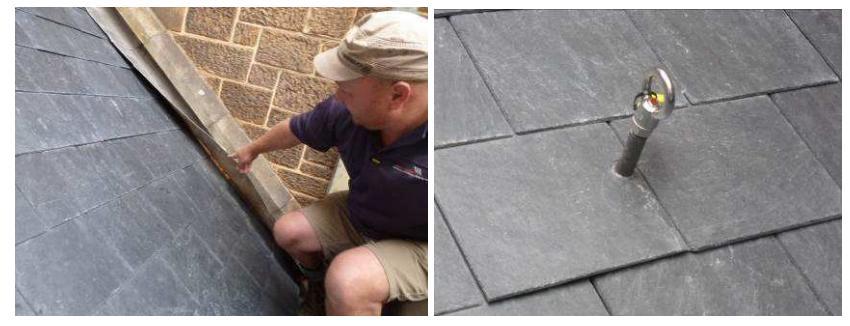
Copper soaker between the slate and the roof safety anchor points

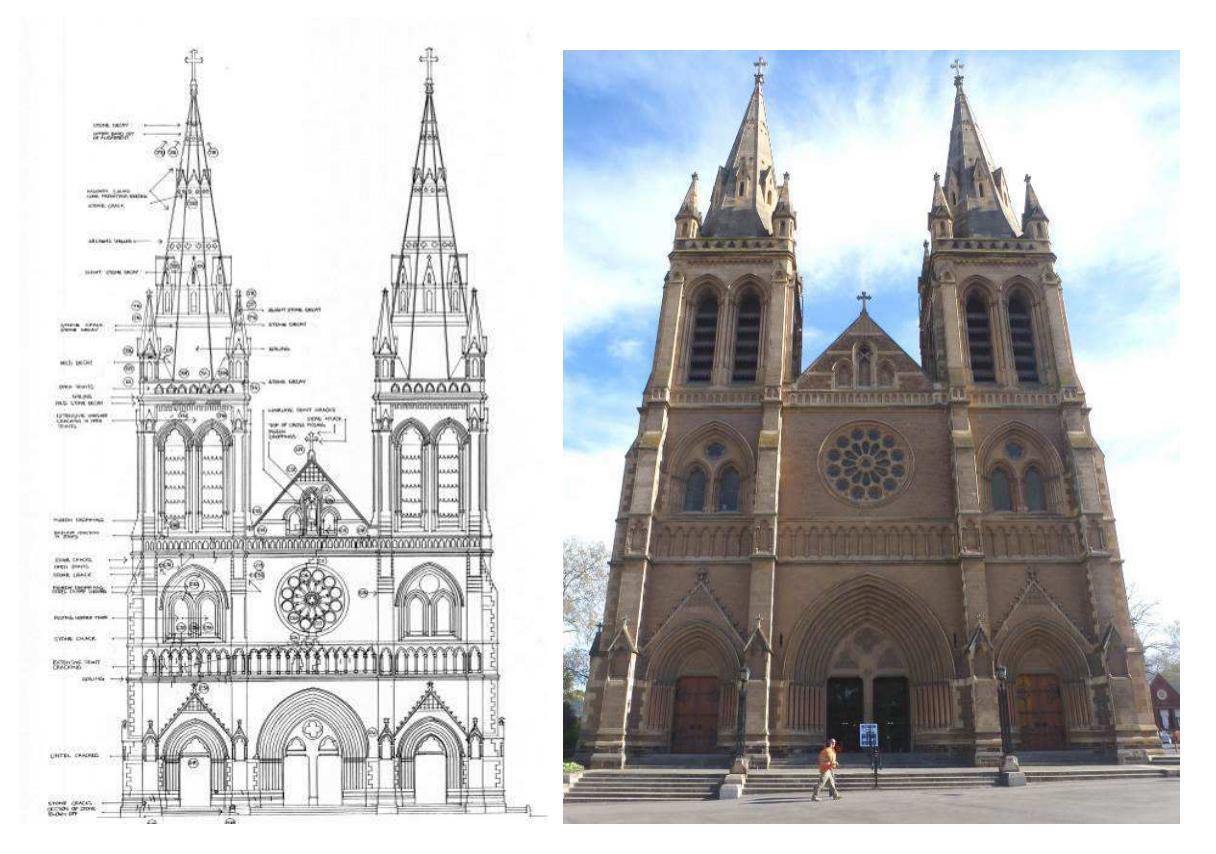
4.2.2 East (Liturgical West) Front Elevation

Generally the front east façade is in sound condition with some areas of stone deterioration. However the façade stone is generally soiled and dirty. The major area of deterioration is in the tower blind balustrades where water collection behind this blind balustrade has caused marked stone deterioration. This deterioration also occurs in the pinnacles.

- General cleaning of the stone facade is required.
- This elevation shows typical soiling and accumulation of lichen to the projecting sandstone and limestone dressings. Areas of accumulated moss and lichen on horizontal surfaces and buttress cappings should be removed using biocide.
- Remove all cement mortar to bluestone plinth and repoint in lime mortar.
- Indent sections of stone where these are deteriorated or missing. Install stone indent to top entrance step in plaza.
- Undertake consolidation of friable and deteriorated limestone using lime mortars and lime mortar consolidation. In particular the balustrade and pinnacles require work.
- Cracked stone lintols over the entrance doors (2) require pinning
- Reinstate missing finial over entrance door
- Undertake all conservation works recommended in the dilapidation survey.

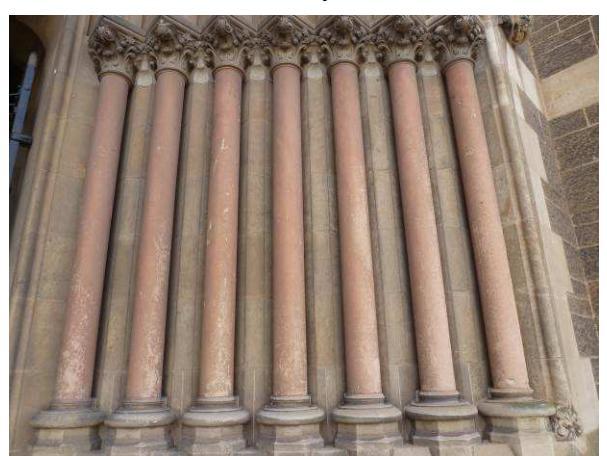
Entry door columns -terracotta colour finish

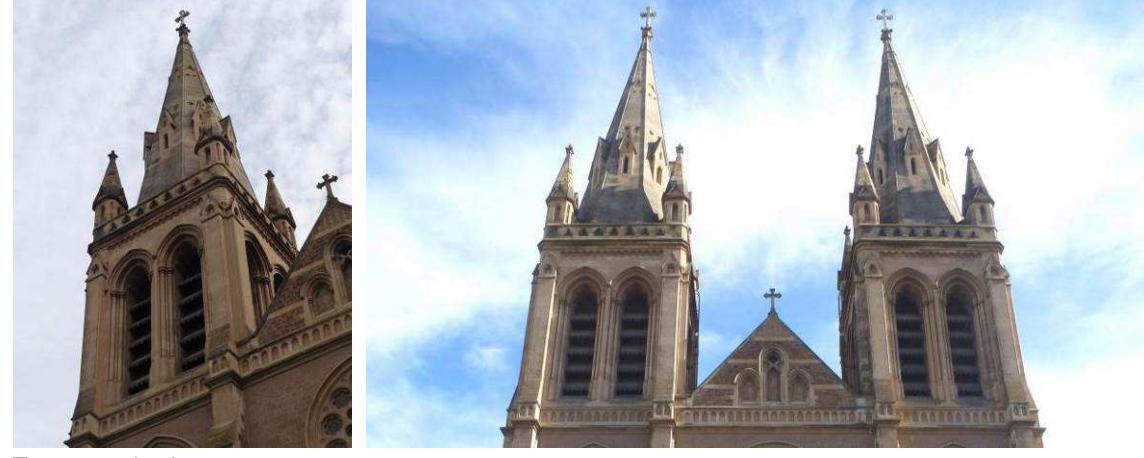
Towers and spires

Tower blind balustrade $% \left({{{\mathbf{r}}_{\mathbf{r}}}_{\mathbf{r}}} \right)$ - deteriorated limestone at the base of the spires

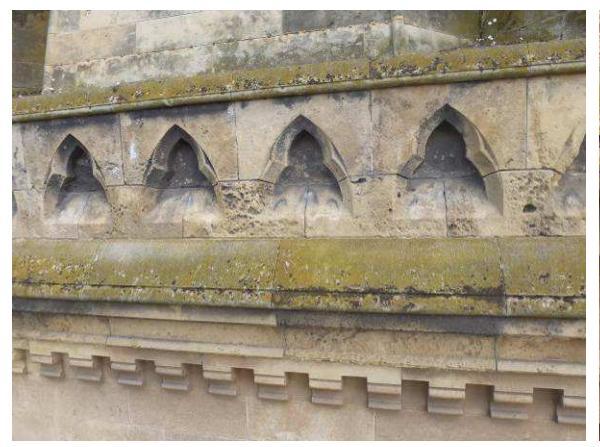
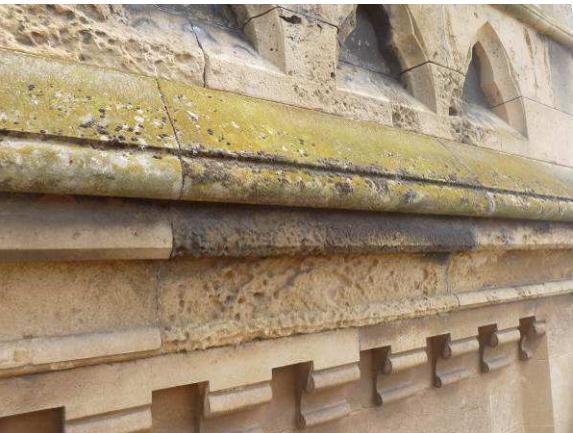
Spire E1 – general view

Spire E1 - stone indent

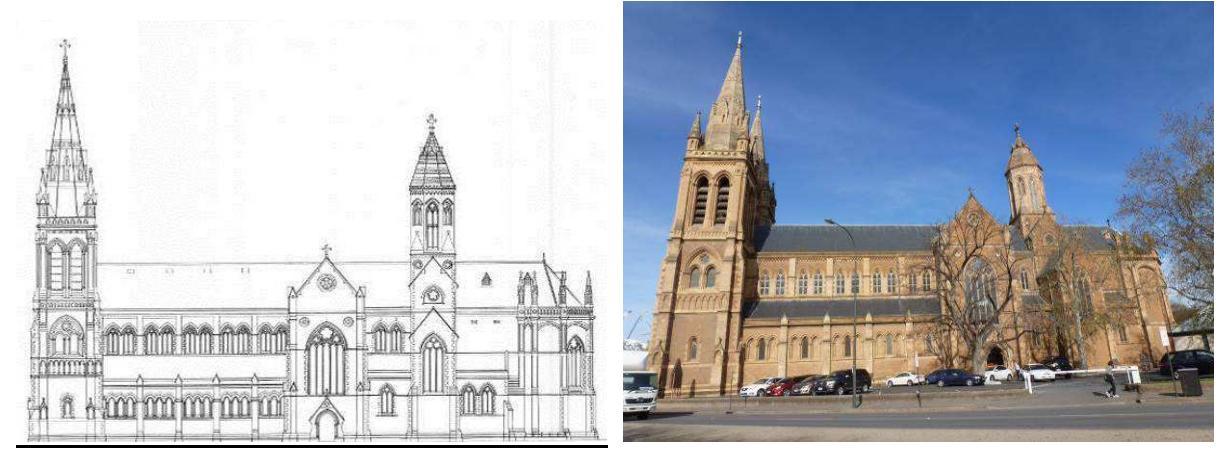
Overall Elevation

Analysis	Recommendations
The north elevation was constructed in stages. Stage One during 1869-1878 included the Sanctuary, the Choir, the Transepts and one bay	General cleaning of the stone facade is required.
only of the Nave. Between 1890-91 the remaining sections of the Nave were constructed, followed by the tower and spires in 1902. Finally the Lady Chapel was erected in 1902-1904.	 This elevation shows typical soiling and accumulation of lichen to the projecting sandstone and limestone dressings. Areas of accumulated moss and lichen on horizontal surfaces and buttress cappings should be
The use of the same materials and detailing makes the stages indistinguishable. Early photographs show the gradual staged building of this façade and the Cathedral as a whole.	removed with using low pressure water, nonmetallic scrapers and brushes followed by the application of a biocide.
The walls are constructed in Tea Tree Gully Sandstone on a Glen Osmond Bluestone plinth. Dressings are in dressed sandstone and fossiliferous limestone.	 Remove all cement pointing mortar to bluestone plinth and repoint in lime mortar. The bluestone plinth has damaged stone and requires total repointing, with some selective stone replacement.

Generally the façade has been maintained well over time.	• Box gutter behind stone parapet – refer roofing section. Internal leaks correspond to
The entry porch to the transept is dated 1891 and incorporates fine cast metal security gates, and well preserved pine access doors with wrought metal hinges. There is evidence of water penetration internally in the porch	 Rectify leakage through base of leadlight windows – shown internally (there is evidence internally of soiling and water ingress).
Flanking the porch entrance are sandstone round columns similar to the east elevation, with skim rendered finish over a sandstone shaft – this was to achieve a contrasting terracotta finish to accentuate the door openings.	• General soiling and build up of dirt and some lichen accumulation – being the north elevation, with greater exposure to sun, this build up is less than the south and east elevations.

Note that the towers and spires are covered under the east elevation.	Undertake all conservation works recommended in the dilapidation survey.
Refer Section 4.2.4 Lady Chapel for discussion of north, west and south elevations of the Lady Chapel.

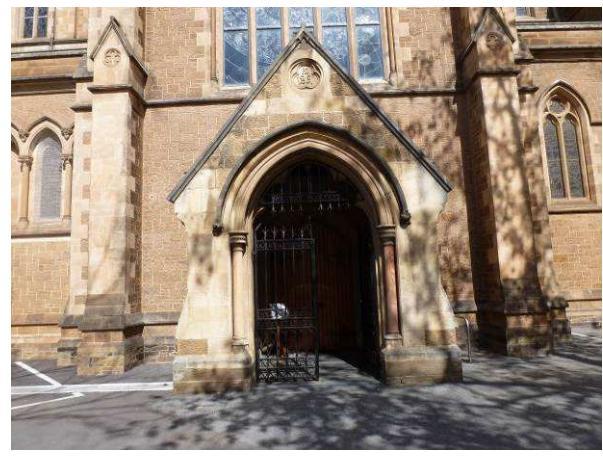
Entry porch to transept

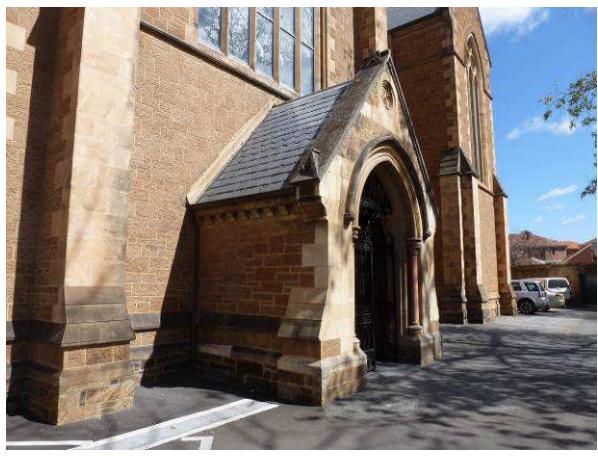
Entry porch to transept

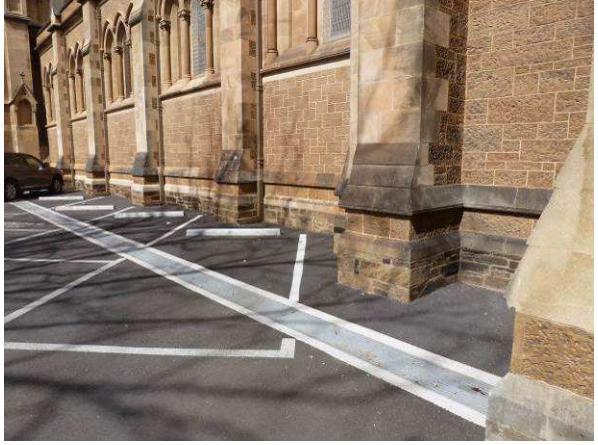
Bitumen to base of wall

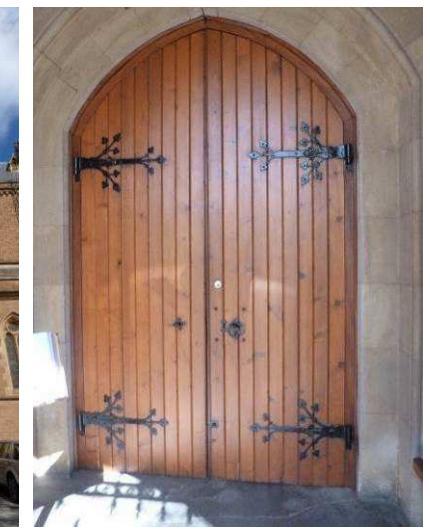
Entry porch door

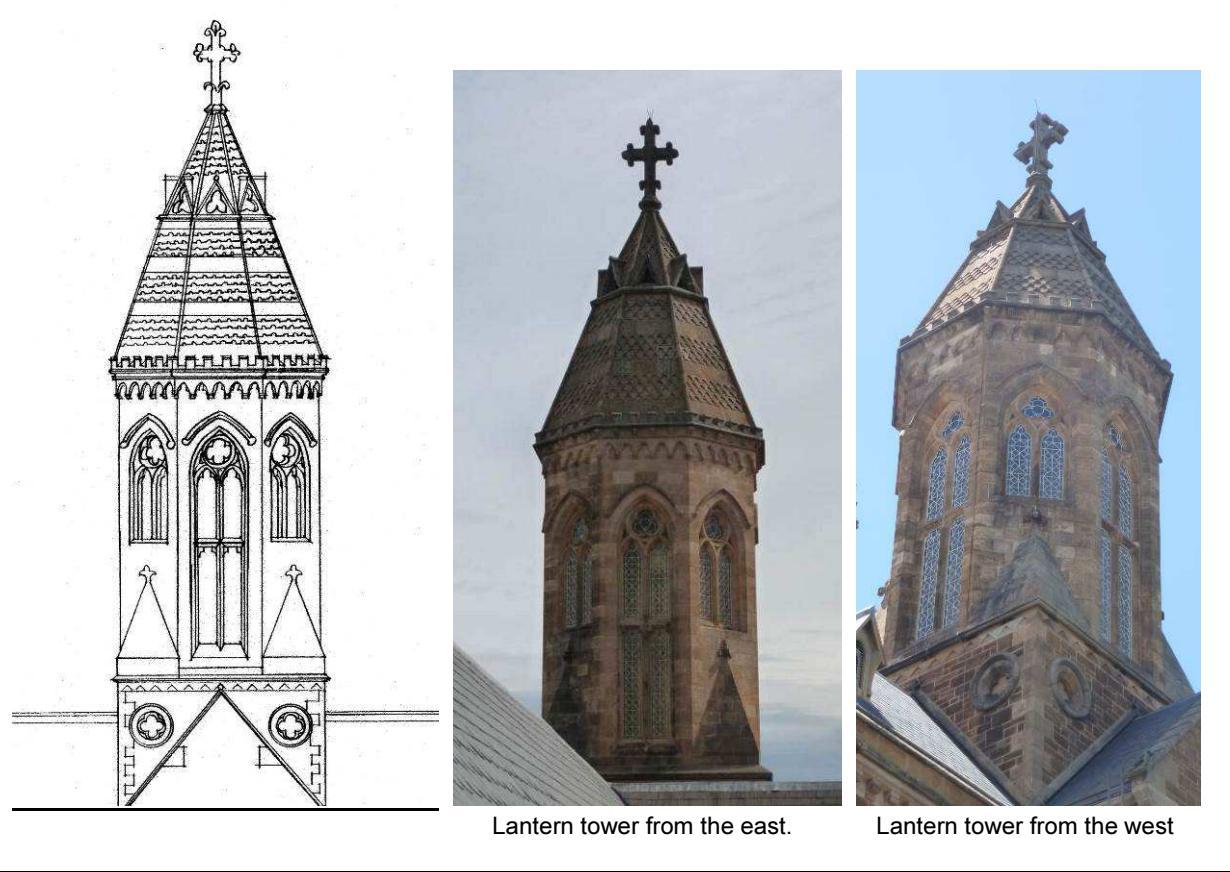
Overall elevation

Analysis	Recommendations
The lantern tower is in very good condition, with conservation works undertaken in 1992. Stone is in good condition, and windows are also in good condition.	 No immediate conservation works are required to the lantern tower. Note that connection of cross to top has not been checked as part of this survey, but was checked in 1992 works General works as outlined in the Dilapidation Survey drawings in the long term.

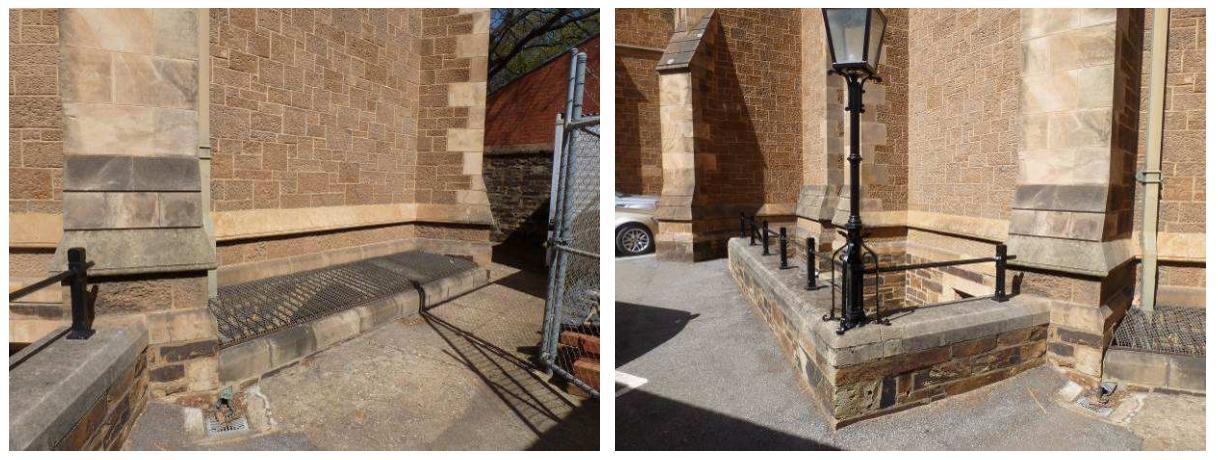
Base of the Lady Chapel

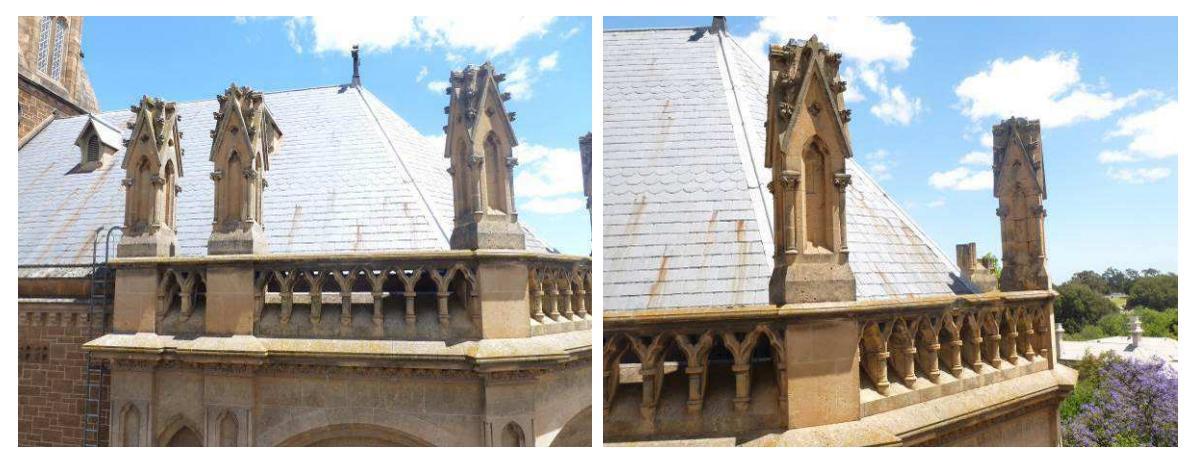
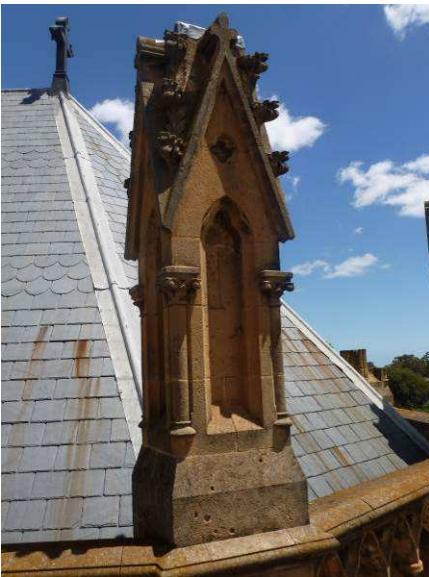
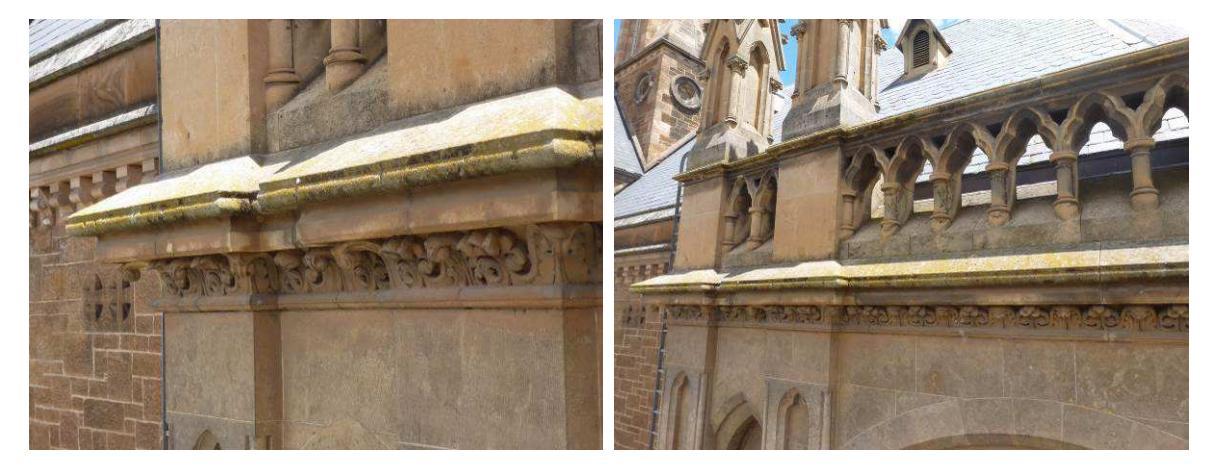
DETERIORATION OF CORNICE, BALUSTRADE AND PINNACLES

DETERIORATION OF CORNICE, BALUSTRADE AND PINNACLES (November 2013 photos)

Damage includes:

- Pitting & washing away of stone face
- Cement render repairs
- Deterioration of copper reinforcing rod
