4.2.5 South Elevation

4.3 Internal Analysis and Recommendations

4.4 Condition Assessment by Engineer

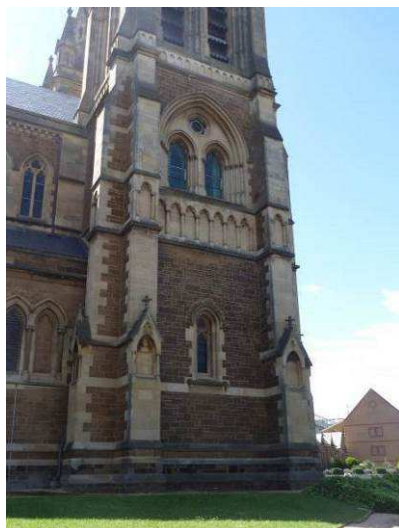
Eastern Bay of South Elevation

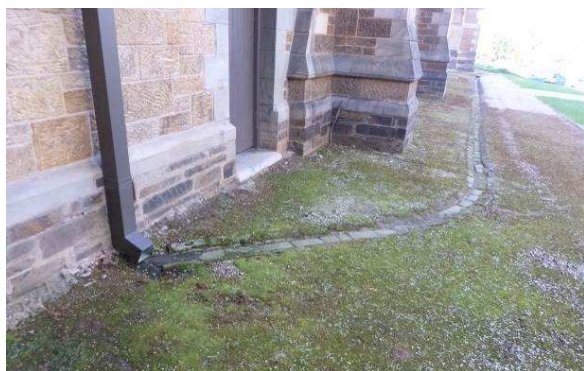
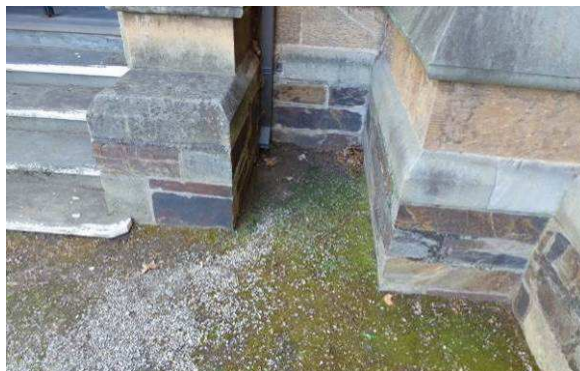
Details of base of South Elevation showing downpipes discharging water on the ground, causing damp ground

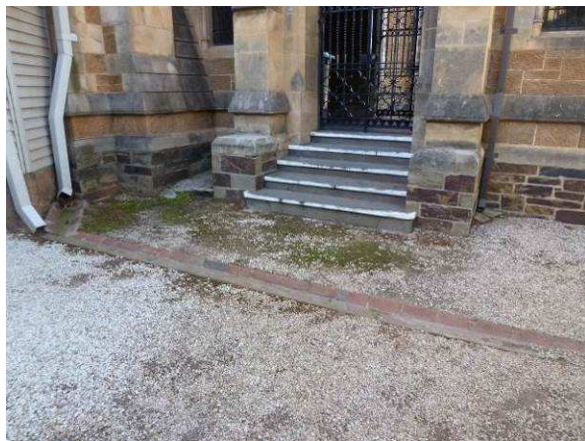
Base of South Elevation - steps to porch (left) and downpipes discharging water into brick drains

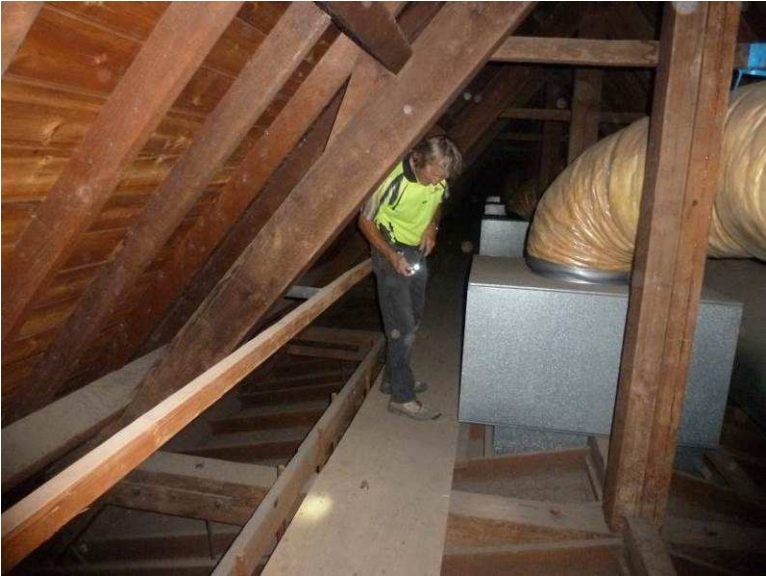
4.3.7 Roof Space

Analysis	Recommendations
<p>The main roof space above the nave and gallery is accessed via the north tower through a roof hatch. The timber roof trusses are constructed of Oregon and generally appear to be in sound condition. However, there is some minor splitting in some of the trusses and king posts (refer to separate engineer's report). The upper side of the ceiling is viewed through the roof space, being tongue & groove boarding. There were previously galvanised iron vents as part of the roof, but these were removed in 1989 when the roof works were undertaken, and the current electrical mechanical venting system was installed. This was undertaken by Butterfields, and was designed by Lincoln Scott with a master switch at ground level. The roof space above the Choir, High Altar and Lady Chapel is not accessible.</p> <p>The walkway to the roof space is not safe and the platform is constructed in ply and under-designed. At the time of inspection, one of these platforms nearly broke with two people on it. This access platform was installed in 1992 but is not adequate and a new access platform system needs to be installed.</p>	<ul style="list-style-type: none">• Install new access walkway platform system, designed specifically for this area, to provide safe access to the internal roof area.• Undertake strengthening in accordance with Engineers recommendations.• Continue to maintain.

The roof was also inspected from within the ceiling space for the accessible portion of the roof between the eastern spires and the lantern tower. The roof timbers are generally in very good condition apart from some defects:

- Splitting in the central vertical timber of the truss, also some opening of the top connection joint of the central vertical
- Some minor splits in other timbers
- The walkway in the roof space is structurally unsound and must be replaced

Some other roof timbers have splits and should be repaired with plywood splice plates glued and nailed along the length of the split.

The central walkway is defective and should be replaced, as well as the roof access platform to the central walkway.

- Provide plywood gusset plates to restrain the top of the central timber vertical in the roof trusses
- Replace the ceiling walkway and roof access platform
- Provide plywood strengthening plates along split roof timbers
- Review the condition of the roof crosses regularly (maximum biannually) for deterioration and repair as necessary, or alternatively carry out restorative work to all roof crosses now.

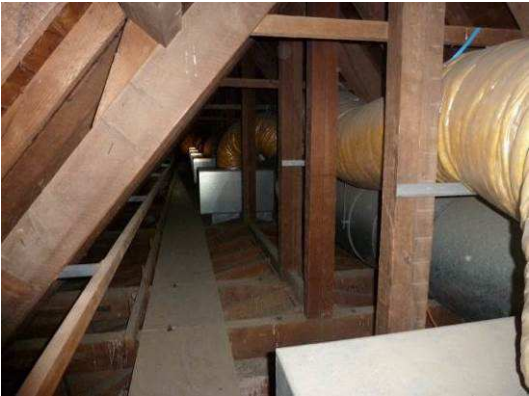
Looking west

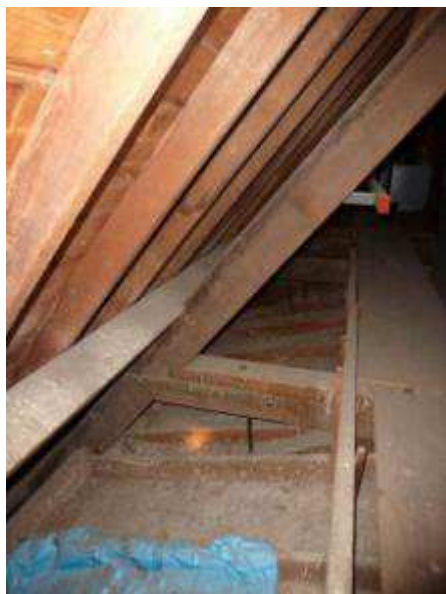
West end of roof space

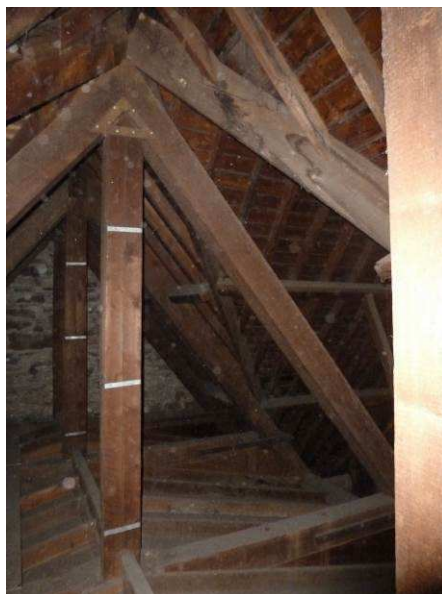
Typical detail

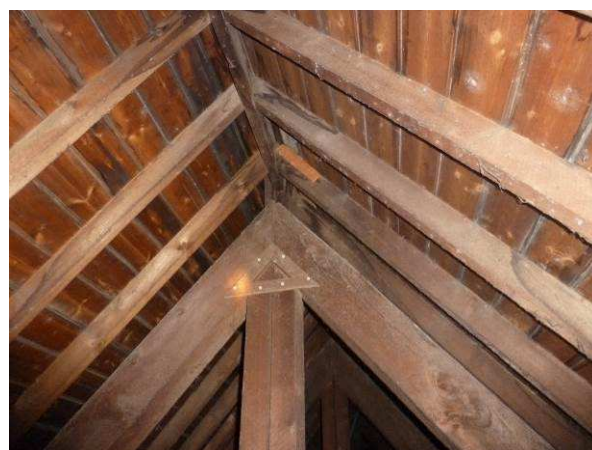
Apex junction with later plate

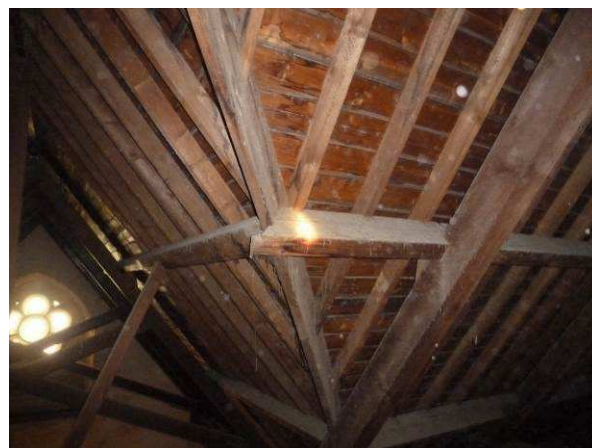
Junction with transept

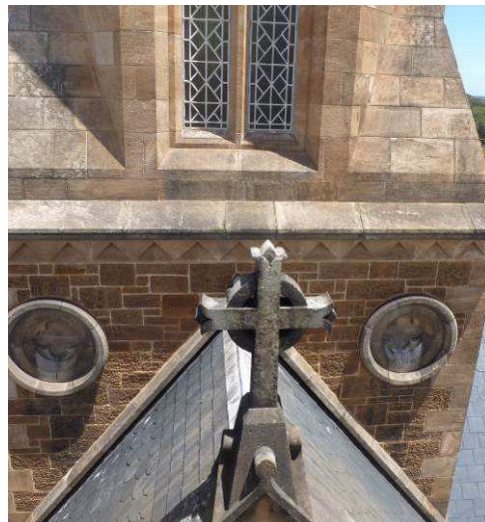
Sandstone to the crossing tower, with sandstone dressings (early 1869 section of Cathedral), note stone cross

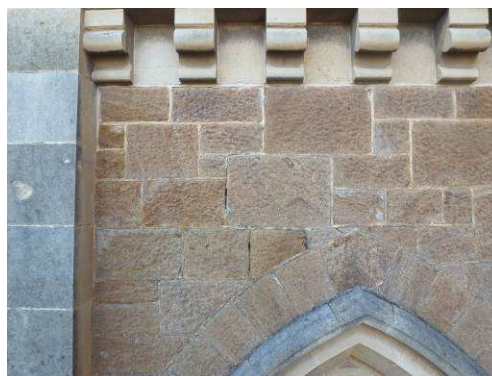
Sandstone to the nave walls, with limestone dressings (extension of nave undertaken in 1890 – 94)
